## **MAZDA R2 / RF**

Part Number 10051025,10051084, 10051081, 10051085, 10051093.

### **Important**

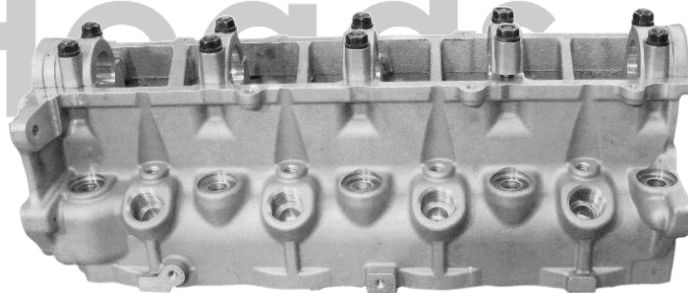
It is widely believed that this type of failure (external cracking of head around the central area) is due to “thermal shock” possibly caused by water pump cavitation and higher temperature thermostat opening settings.

1. Check and flush cooling system.
2. Replace water pump.
3. Replace thermostat, (suggest a 3.5mm by-pass hole be drilled in the skirt to reduce thermal-shock)
4. Service or replace radiator.
